석면비산측정 결과보고서

- 도초 테마가 있는 웰빙소공원
[수국공원(수국온실)조성]지정폐기물 철거공사 -

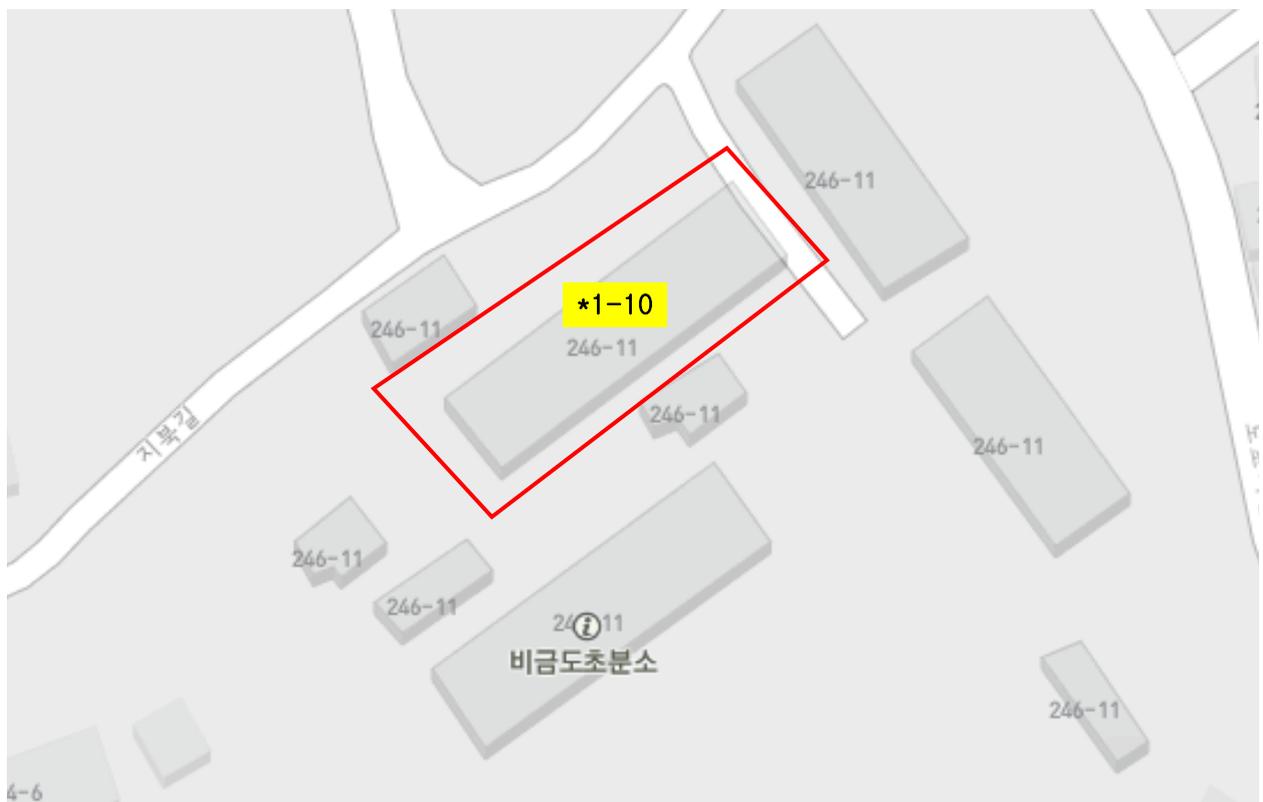
[별 첨1] 측정 위치도(측정 장소)

전라남도 신안군 도초면 도초서길 246-11

범 례

부지경계선

*NO

시료채취

2014. 09. 01.					
측정위치		측정시간(분)	유량(l/min)	측정농도 [기준: 0.01개/cm ³]	초과여부
*1	부지경계선1	14:30 ~ 18:32	9.96	불검출[검출한계 0.002미만]	미만
*2	부지경계선2	14:31 ~ 18:33	9.94	불검출[검출한계 0.002미만]	미만
*3	부지경계선3	14:33 ~ 18:35	9.97	불검출[검출한계 0.002미만]	미만
*4	부지경계선4	14:34 ~ 18:36	9.98	불검출[검출한계 0.002미만]	미만
*5	위생설비입구	14:36 ~ 15:18	9.94	0.002	미만
*6	작업장주변	14:38 ~ 15:20	9.96	불검출[검출한계 0.002미만]	미만
*7	폐기물야적	14:40 ~ 15:22	9.98	불검출[검출한계 0.002미만]	미만
*8	음압기배출구1	14:43 ~ 15:25	9.97	0.003	미만
*9	음압기배출구2	14:46 ~ 15:28	9.93	0.002	미만
*10	음압기배출구3	14:48 ~ 15:30	9.97	불검출[검출한계 0.002미만]	미만
